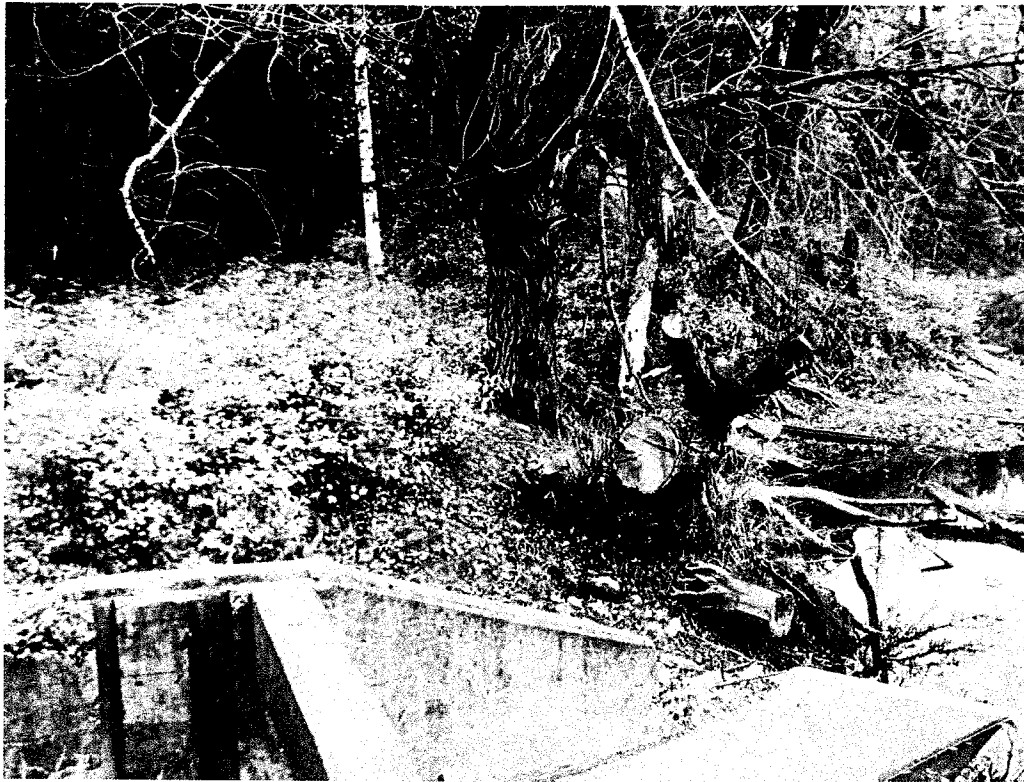
**Figure 1-3 - Trees and stumps on embankment**
